# A simulated bushfire regulatory information report

Test standard: [Clauses 14 and 22 of AS 1530.8.1:2018](#)

Specimen: [MGP10 Radiata Pine subfloor system with mineral wool insulation](#)

Job number: [FRT210172](#)

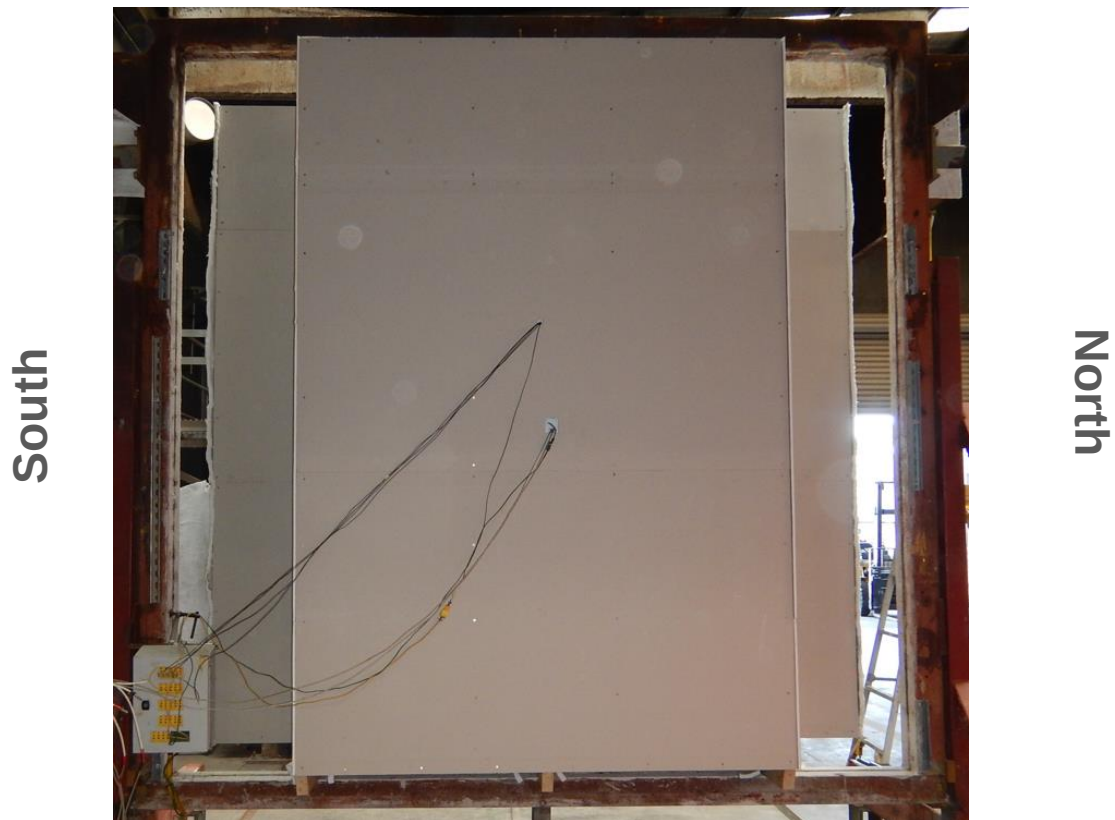
Figure 4 Unexposed face of the specimen before the start of the test

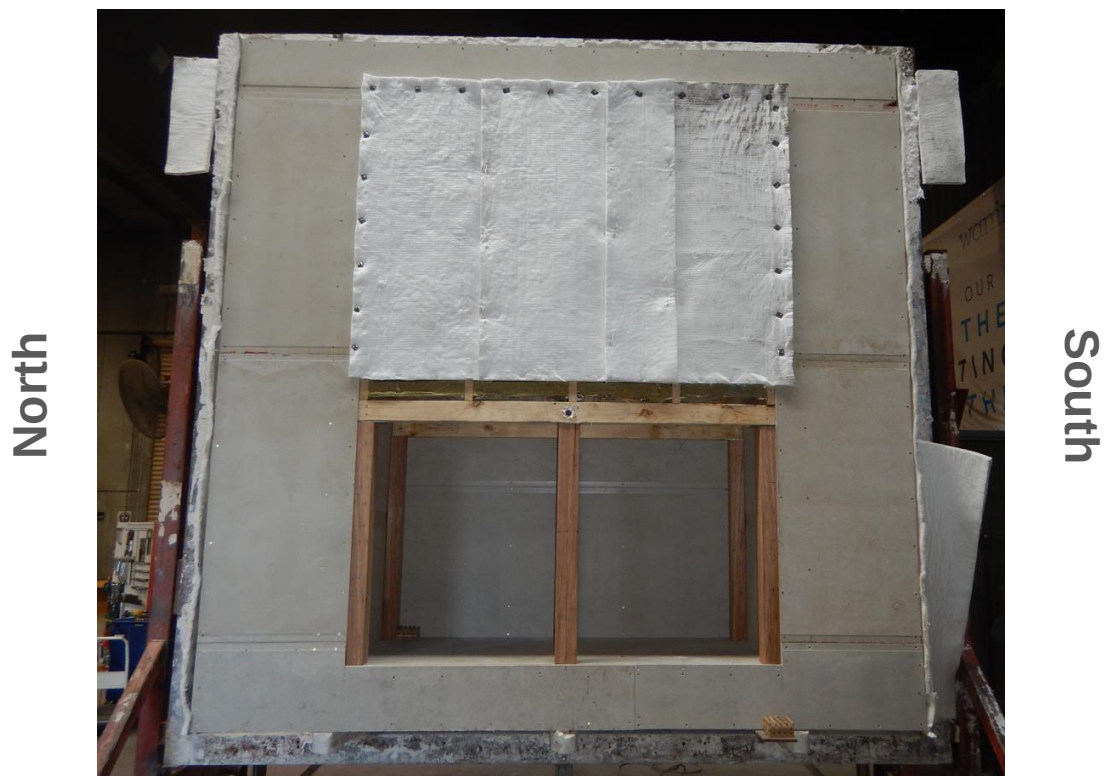
Figure 5 Exposed face of the specimen before the start of the test

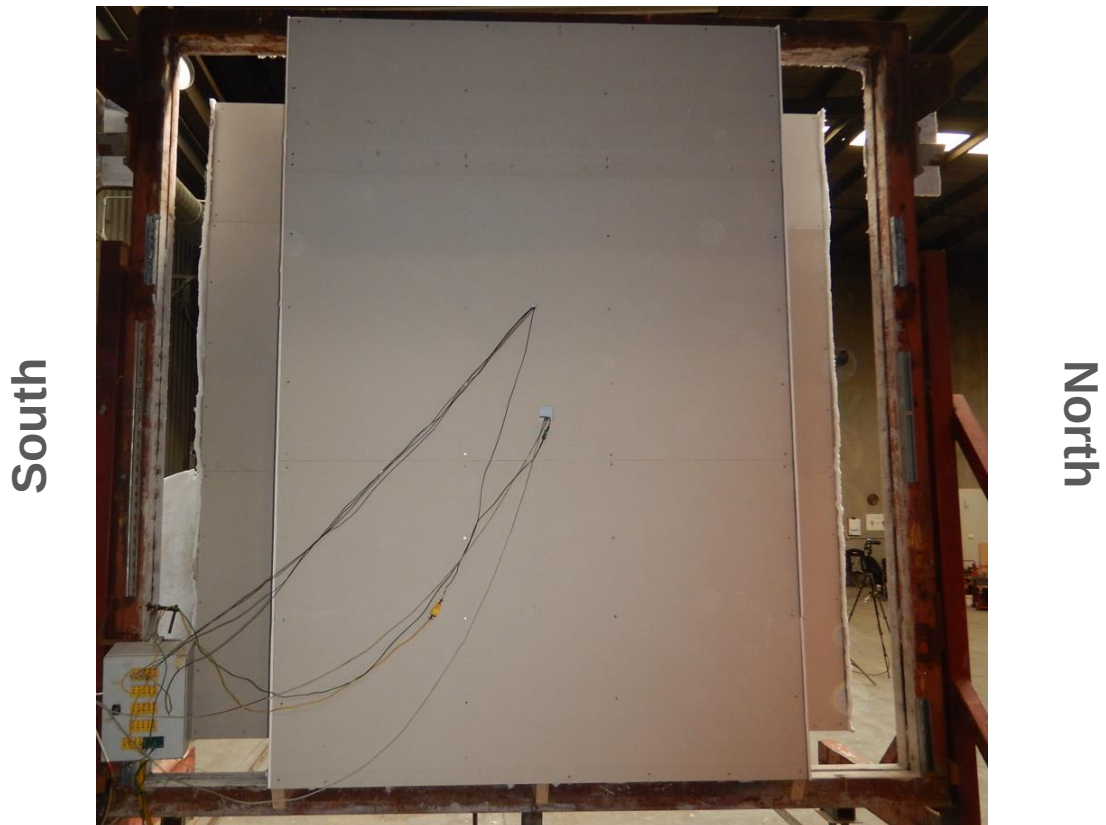
Figure 6 Unexposed face of the specimen at the end of the test

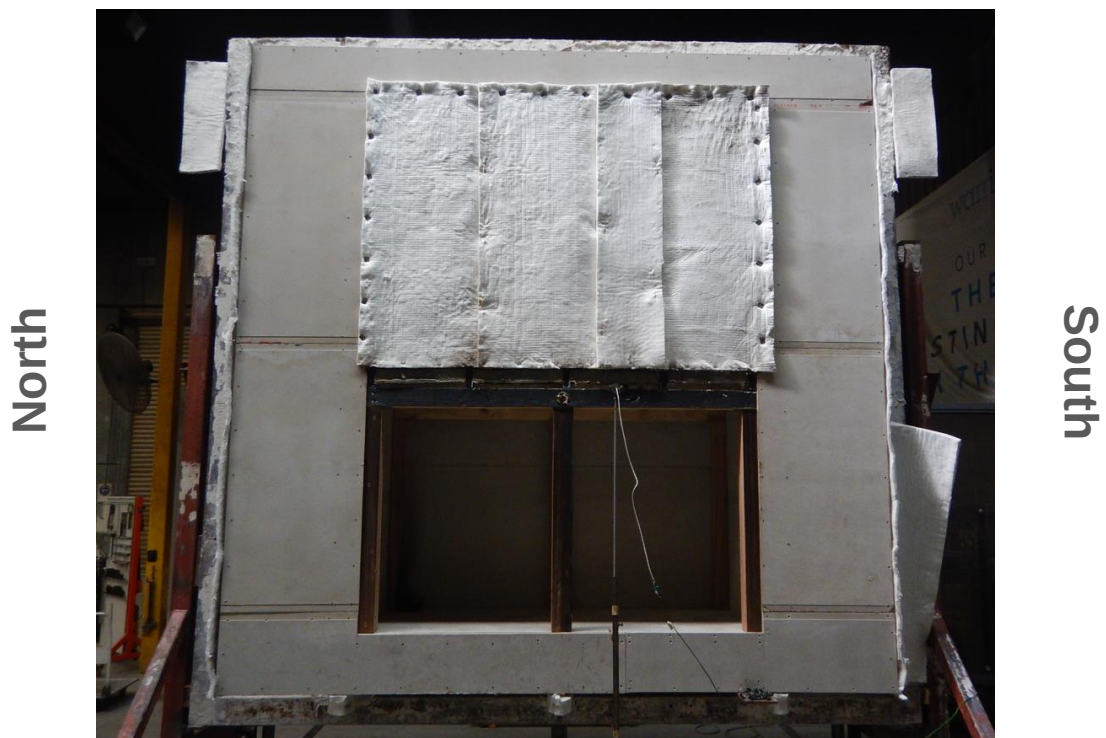
Figure 7 Exposed face of the specimen at the end of the test
