# Impact and Assessment of Moisture-affected Timber-framed Construction

## WoodSolutions Technical Design Guides

Colin MacKenzie

Timber Queensland Limited

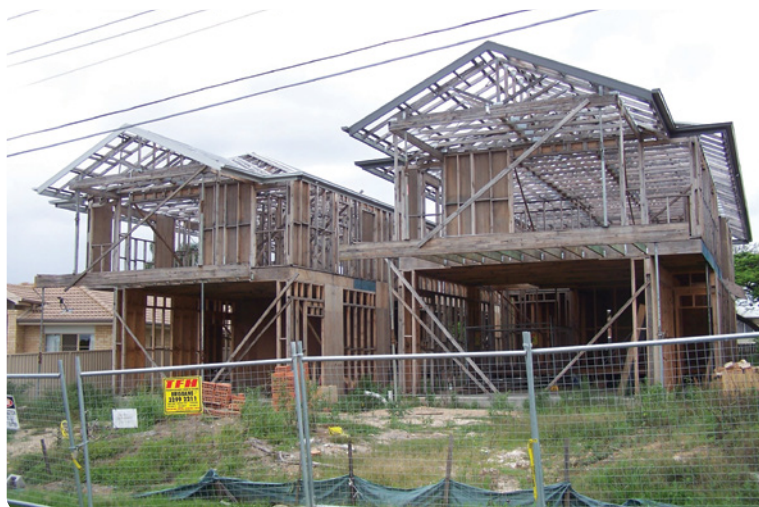
*Timber frames exposed to the weather for six months.*

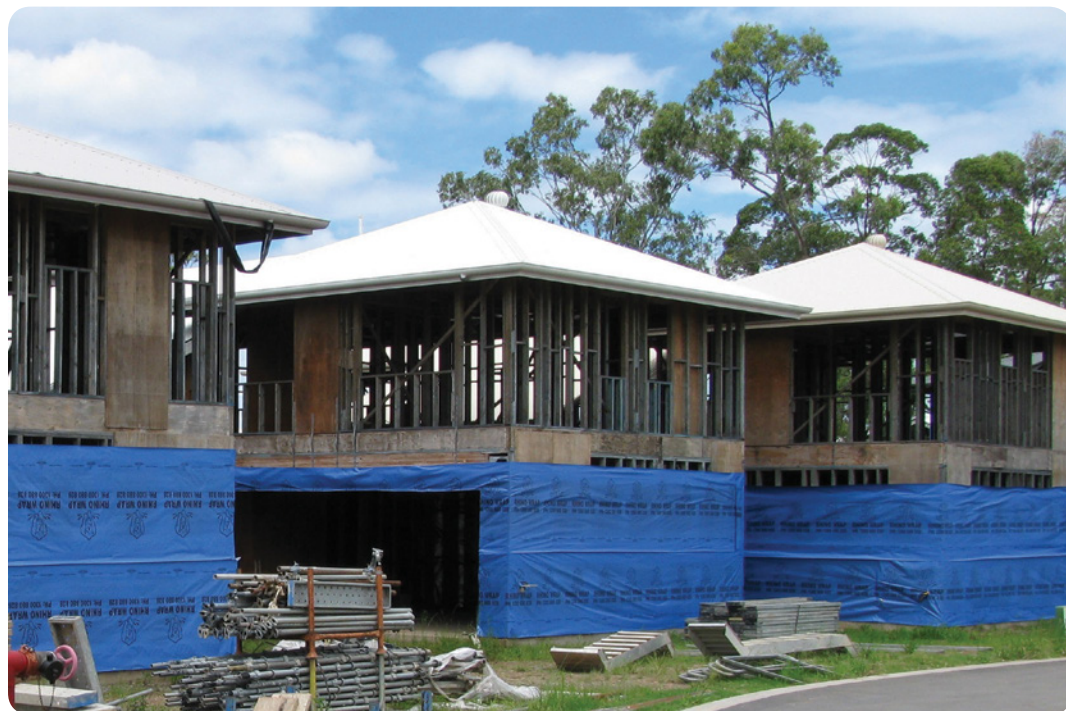
***Exposed timber can become discolored and stained.***

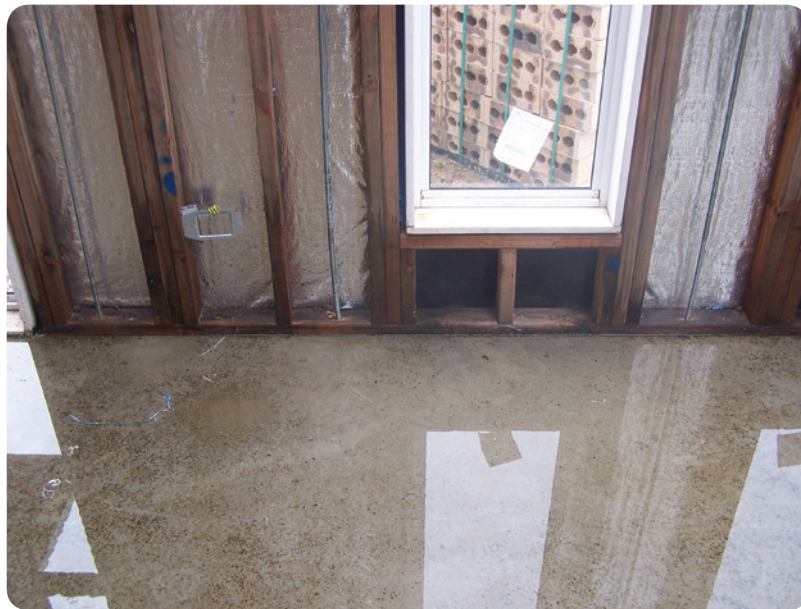
**Water ponding on slab. Note wicking of moisture up the studs.**

The areas of a weather-exposed frame likely to have the highest moisture content are bottom plates on slabs or sheet floors and the lower ends of studs on these plates due to wicking action.

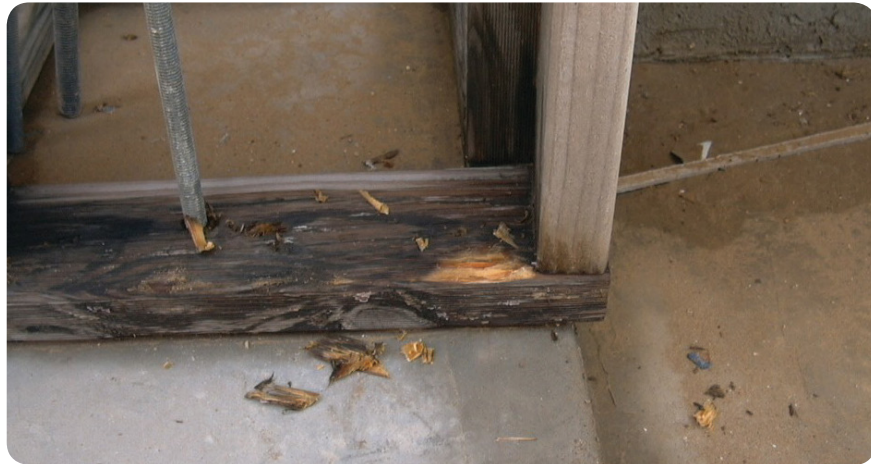
**Significant discolouration due to stain but timber under surface is unaffected, with no decay.**

Their impact can be easily established by scraping back the timber surface. Where the timber just below the surface is similar to 'fresh' timber, there will have been negligible or no deterioration.

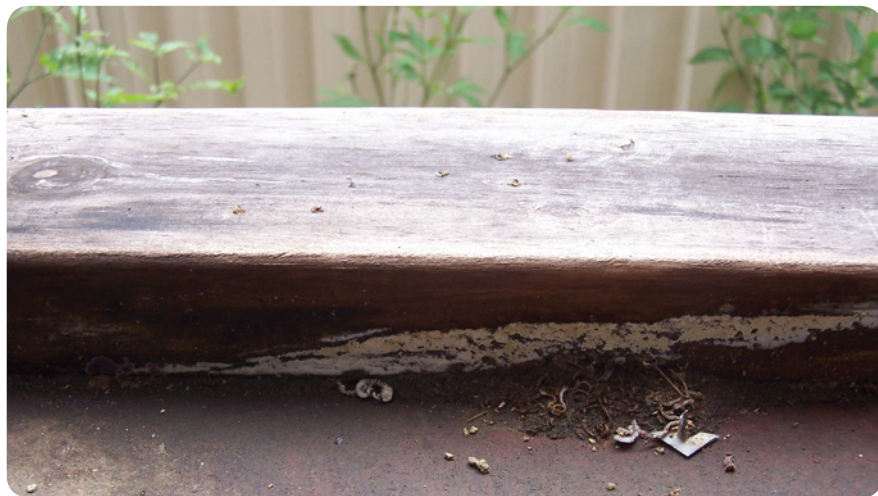
**Decay in bottom plate on particleboard floor. Note small drill holes on top of plate used to detect decay.**

Drilling using a fine auger or drill bit enables assessment deeper into the timber. Again, for the equipment being used, the force required to penetrate sound timber should be compared to the force required to penetrate affected timber. Timber that has decayed will be far more easily penetrated.

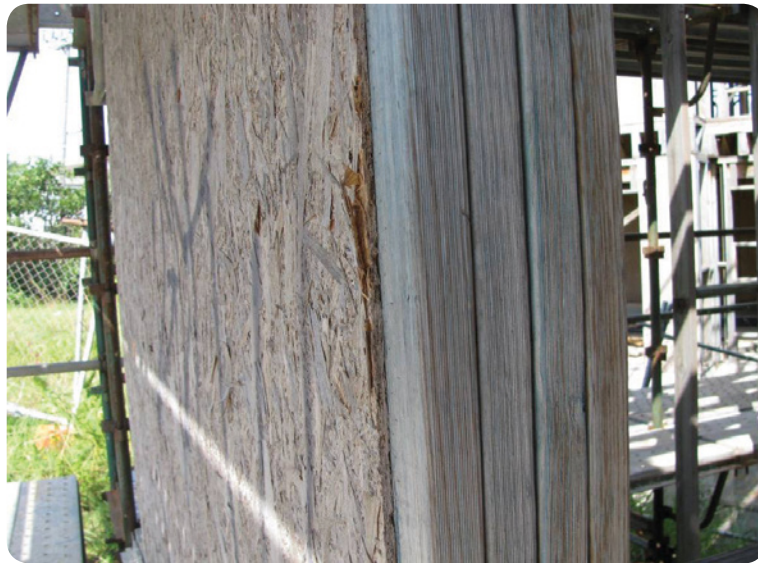
***Example of OSB sheet bracing showing edge swelling and flaking.***

With all sheet bracing types, the critical areas for evaluation are the sheet edges where the nail or other fasteners attach the sheet to the frame. Any degradation of the sheet edges will compromise the structural adequacy and shear capacity of the fasteners which, in turn, will affect the design capacity of the bracing.

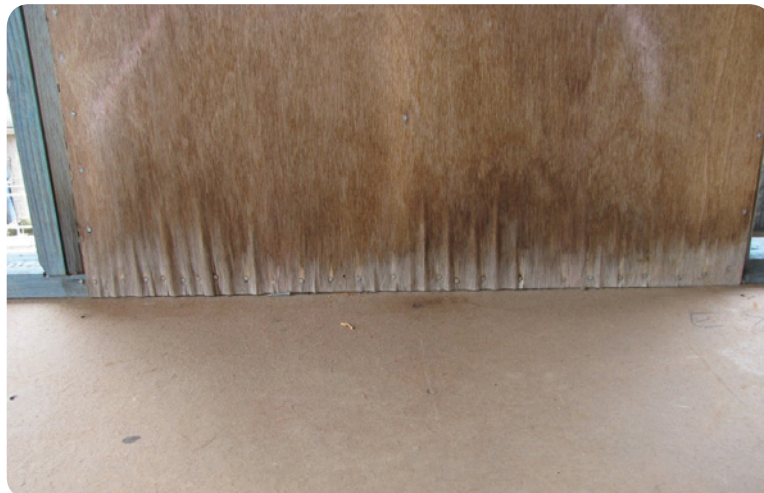
***Plywood delamination at bottom plate in bracing panel. Note: The plywood used in the construction in the above example had no identification stamps or indication of certification schemes or Australian Standard for its manufacture.***

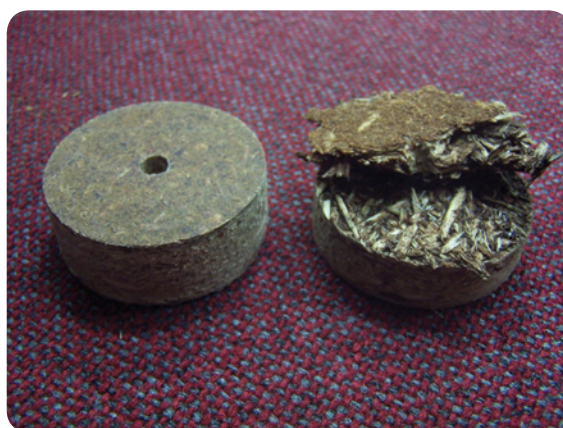
**Typical hole saw samples.**

An additional advantage of taking hole saw samples is that the moisture content in the board can be ascertained by oven dry testing. This also enables the thickness of the sample to be measured following drying to determine the extent of any non-recoverable swelling.

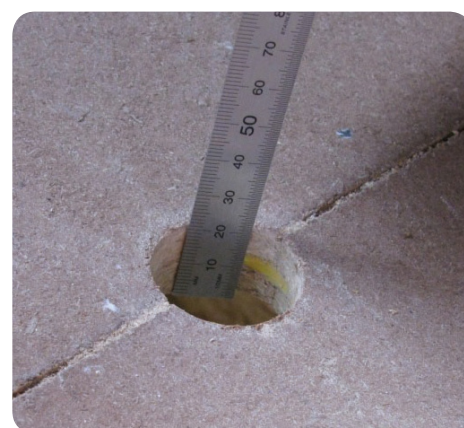
**Measuring the thickness of particleboard flooring at a hole saw sample location.**

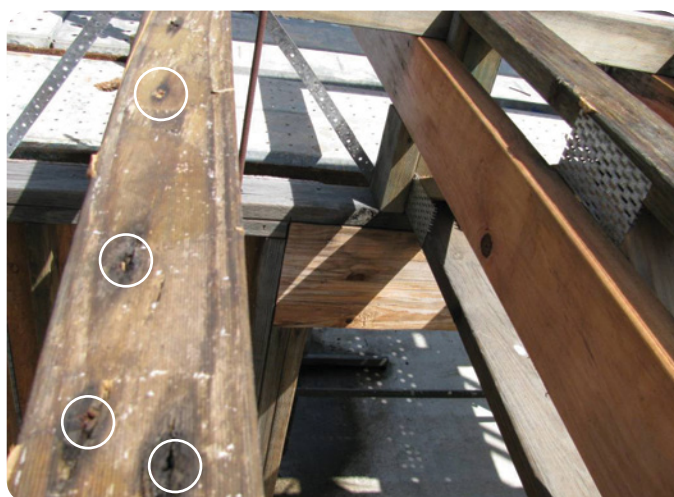
**Decay pockets (highlighted) around fixing points where sheet flooring has been removed after 12 months' weather exposure.**

*Moisture can track down fittings into joists, creating local decay pockets.*

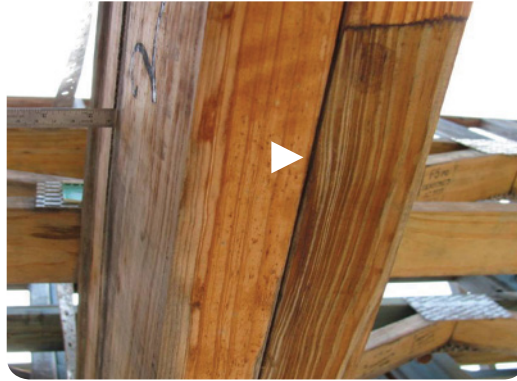
***Split (indicated by arrow) totally through one of the doubled glued-laminated beams. Depth of split indicated by ruler 35 mm plus.***

A visual inspection of laminated or LVL beams will generally reveal any checking, splitting or delamination that has occurred due to the weather exposure. Where found, the extent (length and depth) of any splits or delamination should be further assessed and recorded using a ruler/tape and fine feeler gauge to establish depth.

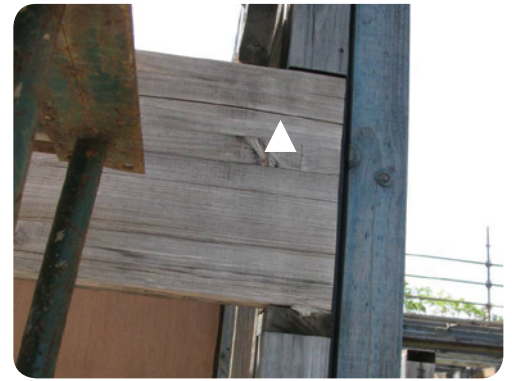
***Split (indicated by arrow) along second top laminate (does not follow glue line) at end of beam.***

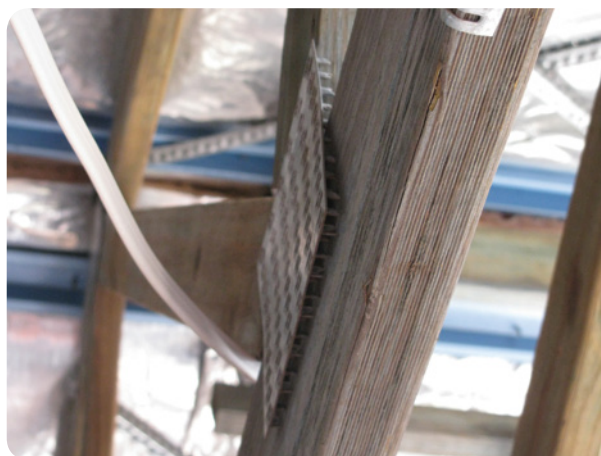
***Loose truss plates where trusses exposed to weather for six months (prior to roofing being installed).***

Repeated cycles of wetting and drying of nail-plated (truss plates) timber products frequently leads to the nailplates 'withdrawing' from the timber due to the associated cyclic expansion and contraction in the timber. In extreme cases, the plates may totally disengage. Where the gap between the plates and the timber is more than 1-2 mm, which can be measured using feeler gauges, the structural integrity of the members or product may be severely compromised. If the structural integrity is in doubt, the nail plate/product manufacturer's advice on repair or replacement should be sought.

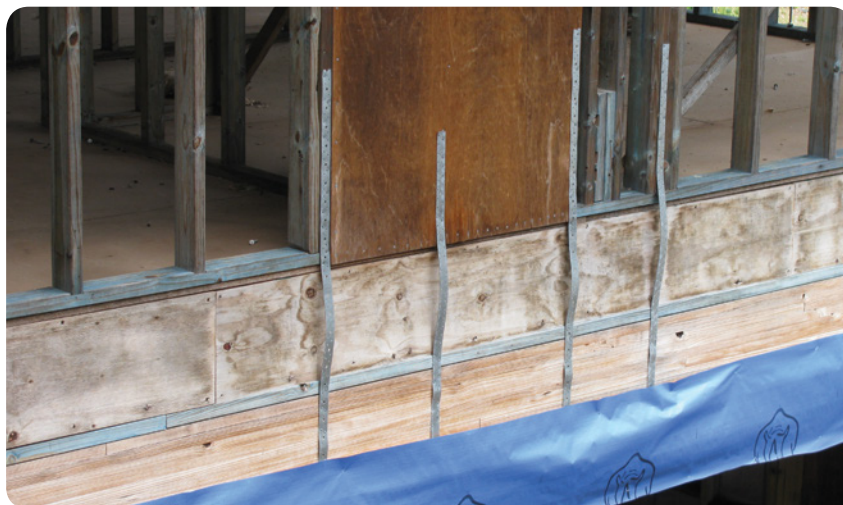
***Loose tie-down steps due to timber expansion and then subsequent shrinkage.***

As shown in the example below, the weather exposure of frames can cause connections such as straps and tie-down rods to become loose. This can be due to either minor frame settlement and/or wetting and expansion of the timbers and subsequent drying and shrinkage. These situations will not usually be due to degradation of the timber in the frames and can be easily rectified. They should not present any real structural concerns.

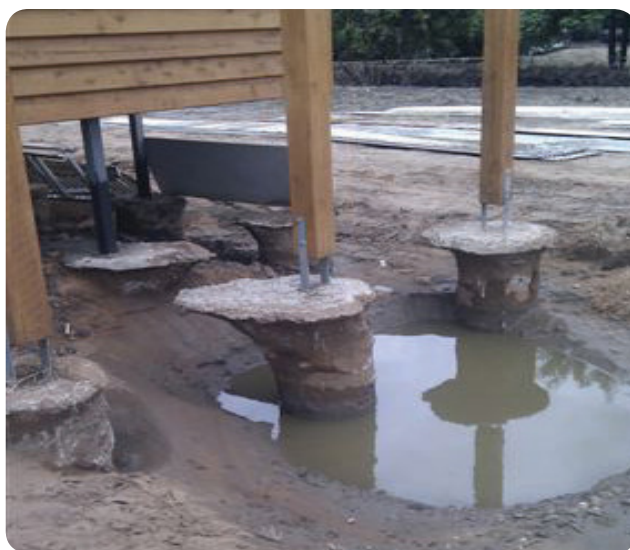
*Footings scoured out by floodwaters (Image: BSA Queensland).*

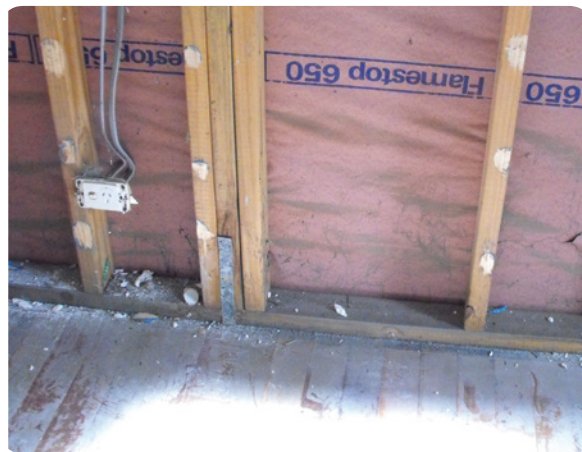
***Although quite stained and covered with mud and silt, when cleaned, the pine framing found to be unaffected***

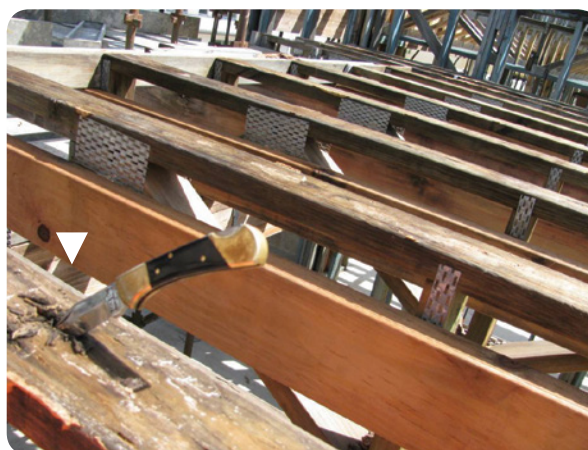
***Locate decay by probing.***

***Decayed timber is soft and spongy and can easily be penetrated with a knife or screwdriver (see arrow).***

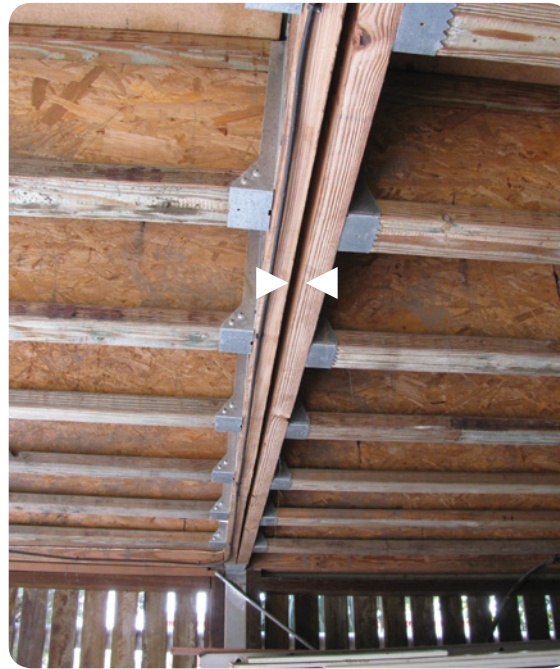
**Expansion in flood-affected timber flooring.**

**Expansion of the hardwood T&G floor above has caused the separation of double bearers (see arrows).**

Timber and wood-based products that have been saturated will swell. When they dry out, they will shrink. The amount of swelling or shrinkage depends on the type and species of timber or type of wood product, and the time exposed to water. Where timber has swollen in, for example, flooring, it may also have secondary effects such as cupping and pushing out external walls or movement of joists and bearers.

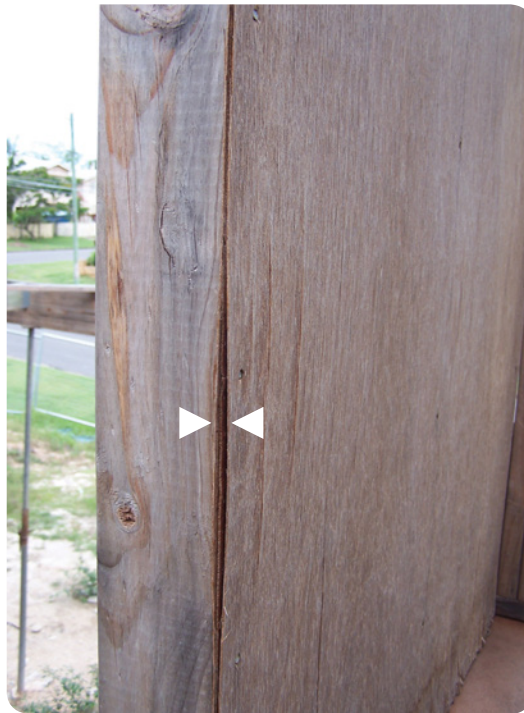
**Delamination of plywood sheet bracing (see arrows).**

**Plywood sheet bracing affected by moisture. Replacement required. Where necessary fix temporary braces.**

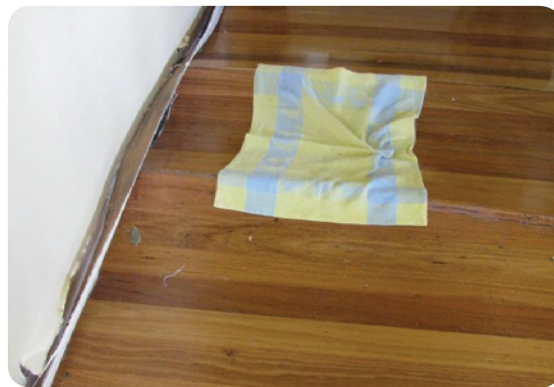
***Tenting of T&G floor due to prolonged moisture being trapped under the floor. This inundated T&G floor supported on a particleboard sub-floor 'tented' about one week after the flood water receded.***

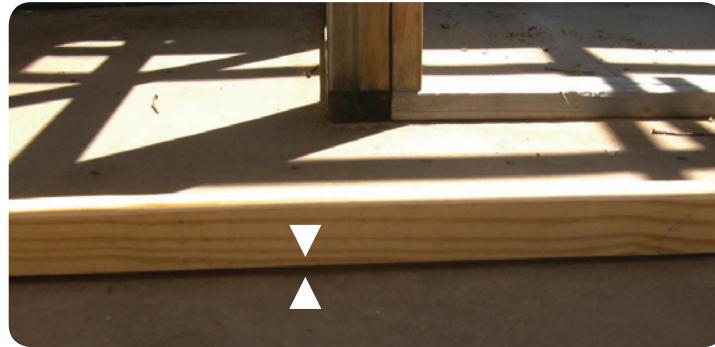
**Use a straight edge to estimate edge swelling in particleboard flooring. Gap between straight edge and floor (see arrows) indicates edge swelling in particleboard flooring.**

Allow the particleboard flooring a minimum of four months to dry out before re-assessing and carrying out any rectification that may be required. As a guide, if sheet edges have swollen more than 5 mm (i.e. would need to be sanded back by 5 mm or more to get a flat floor) then the structural adequacy of the flooring has been compromised and needs rectification by either replacement or installation of a new structural floor over the existing particleboard. Where there is doubt as to the structural adequacy of the particleboard floor, consult the flooring manufacturer.

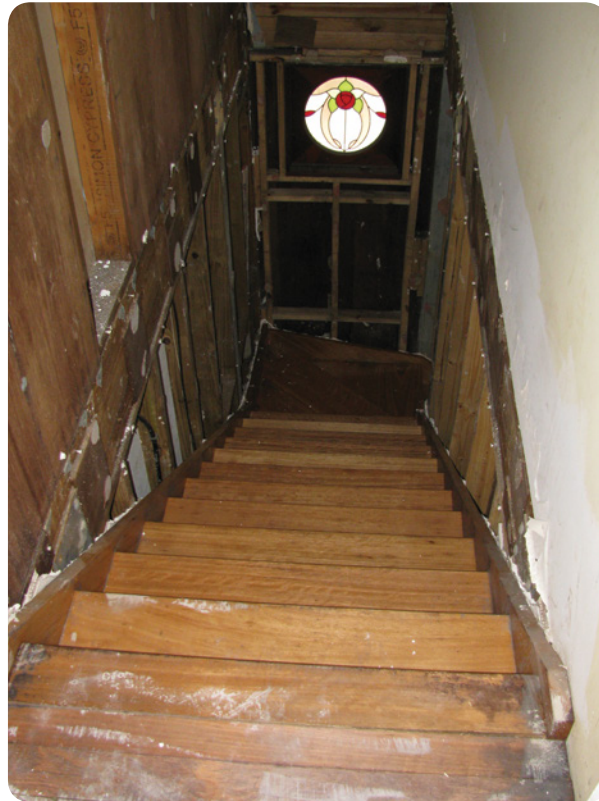
***Solid timber stairs stripped out and allowed to dry were recovered following inundation.***

Stairs constructed from solid timber (hardwood or softwood), glued-laminated timber or structural plywood can usually be recovered provided any surface materials, such as carpet, attached to the underlying stair structure are removed, and the stairs are allowed to dry quickly. Because of their nature, with many housed joints, etc, forced mechanical ventilation or dehumidification may be required to enable timely drying of the stair system.

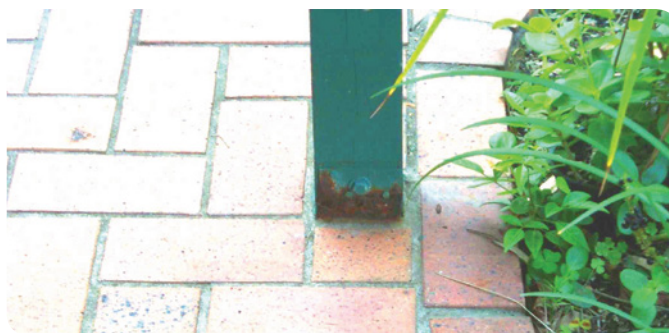
**Significant corrosion of embedded galvanised steel post bracket.**

When assessing timber construction, pay attention to the potential impacts of corroded metal components and connections. Pay particular attention to any non-galvanised items, including bright steel nails, bolts or screws and also to galvanised components such as SHS posts or stirrups that are embedded in concrete and will be susceptible to corrosion at the top of footing. It may be necessary to remove some items (screws/bolts, etc) to assess the extent of corrosion on the embedded portion of the fastener. Where rust is present but the posts are still viable, they should be cleaned, treated with phosphoric acid, and then sealed with a metal primer, followed by subsequent coats of a metal or bituminous paint product.

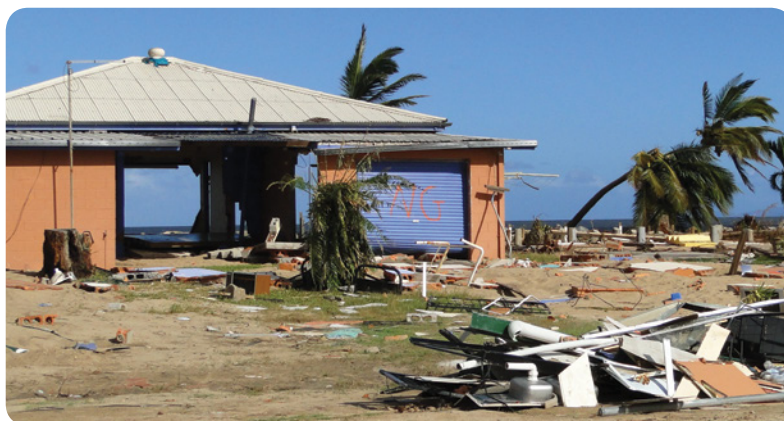
**Storm surge damage to a slab on ground house.**  
(Image: Cyclone Testing Station, James Cook University, Townsville)

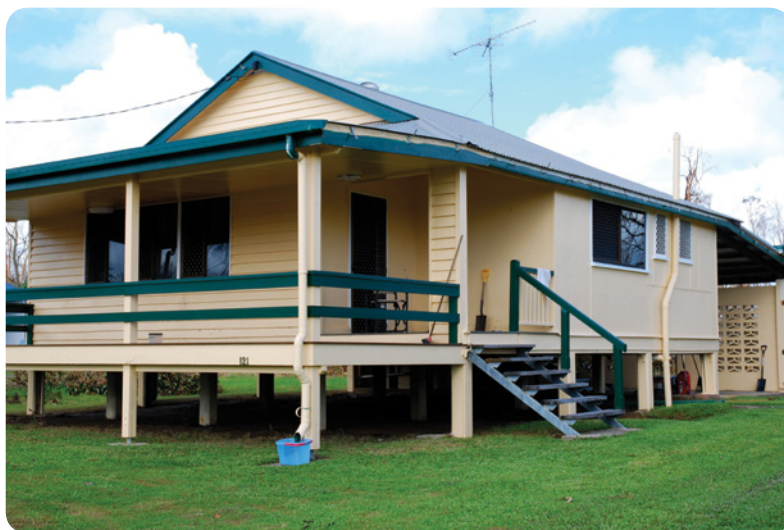
**Elevated houses suffered little storm surge damage.**  
(Image: Cyclone Testing Station, James Cook University, Townsville)

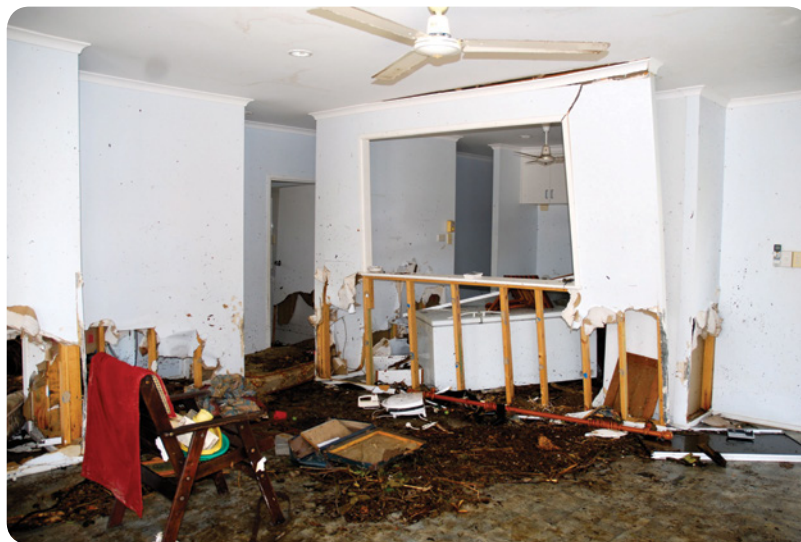
**Storm surge structural damage. (Image: Cyclone Testing Station, James Cook University, Townsville)**

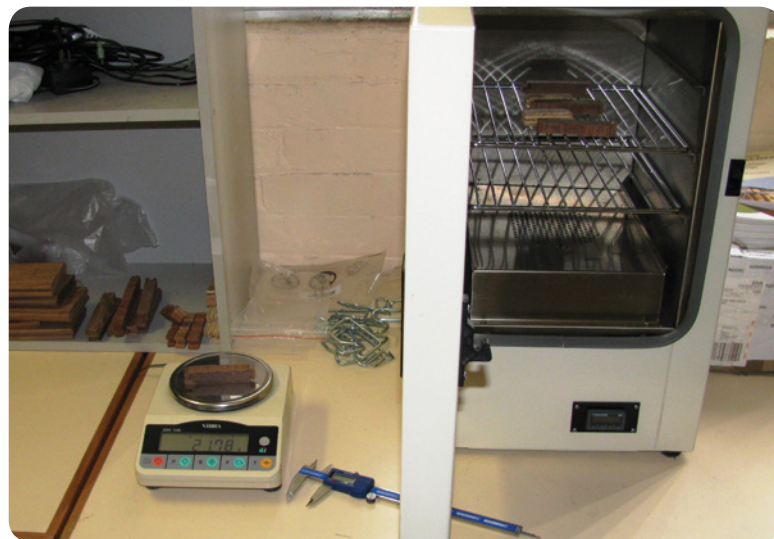
- The equipment required is an accurate electronic digital scales (+/-0.2 grams) and a laboratory oven that is able to maintain a temperature of  $103^{\circ}\text{C} \pm 2^{\circ}\text{C}$ .

**Oven dry moisture content measurement.**

- Oven dry testing is often carried out where there are variations in the MC of the final product.
- It can have a significant affect on the performance of the product. In case of disputes, Australian Standards generally refer to this method as it provides measurements that are more accurate and reliable. For some products, such as preservative-treated timber or particleboard, it is the only method recommended.
- Manufacturers of board products often undertake oven dry testing as a check in the manufacture of their products.
- A number of organisations have the appropriate testing equipment and contract out these services.

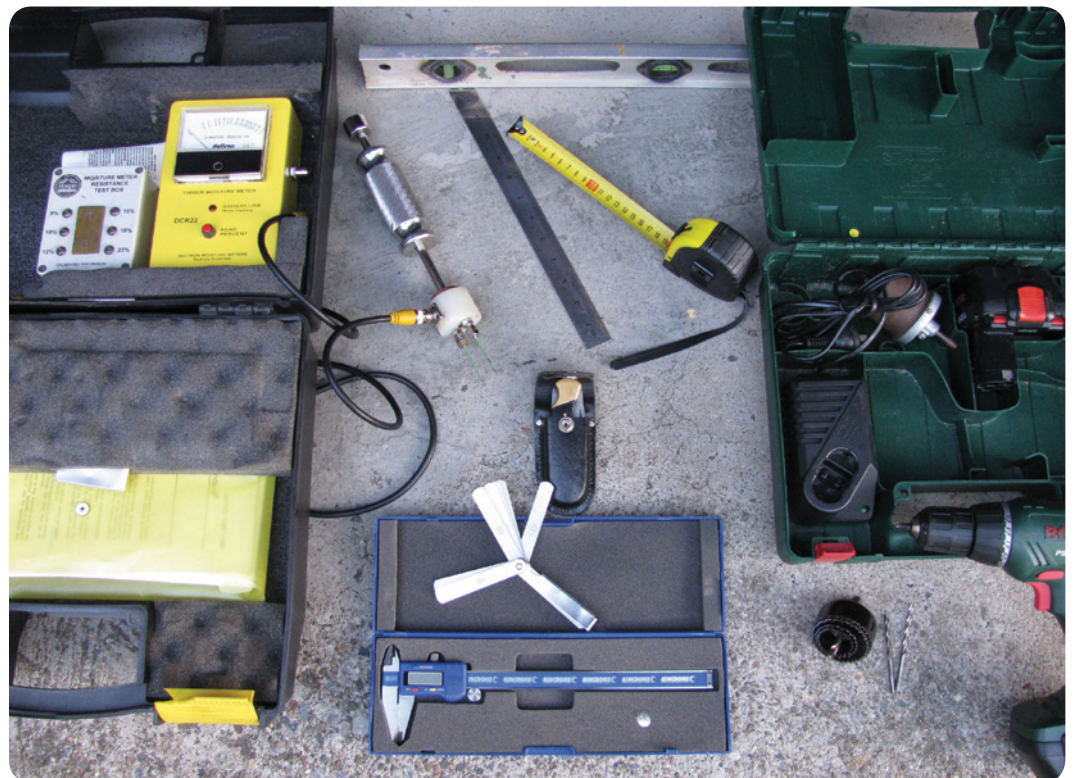
*Typical range of site assessment tools.*

**String line:** Useful for assessing out of straightness over long distances.

**Compass:** It is usually important when undertaking site inspections and reports to be able to determine north. This assists with recording site locations of measurements and also can aid in understanding assessment issues that may arise on-site between one part of the building and another.

**Site notebook:** Record findings on-site such as locations, measurements, sketches, moisture readings, etc. Don't trust your memory.
